ACME Steel/Brass Foundry Draft Upland Site Summary

ACME STEEL/BRASS FOUNDRY (DAR SITE ID #25)

Address:	72 Anthony Street, Brooklyn, Kings County, New York 11222
Tax Lot Parcel(s):	Brooklyn Block 2820, Lot 5
Latitude:	40.723562
Longitude:	-73.9352
Regulatory Programs/	
Numbers/Codes:	NYSDEC No. C224132
Analytical Data Status:	Electronic Data Available Hardcopies only
	No Data Available

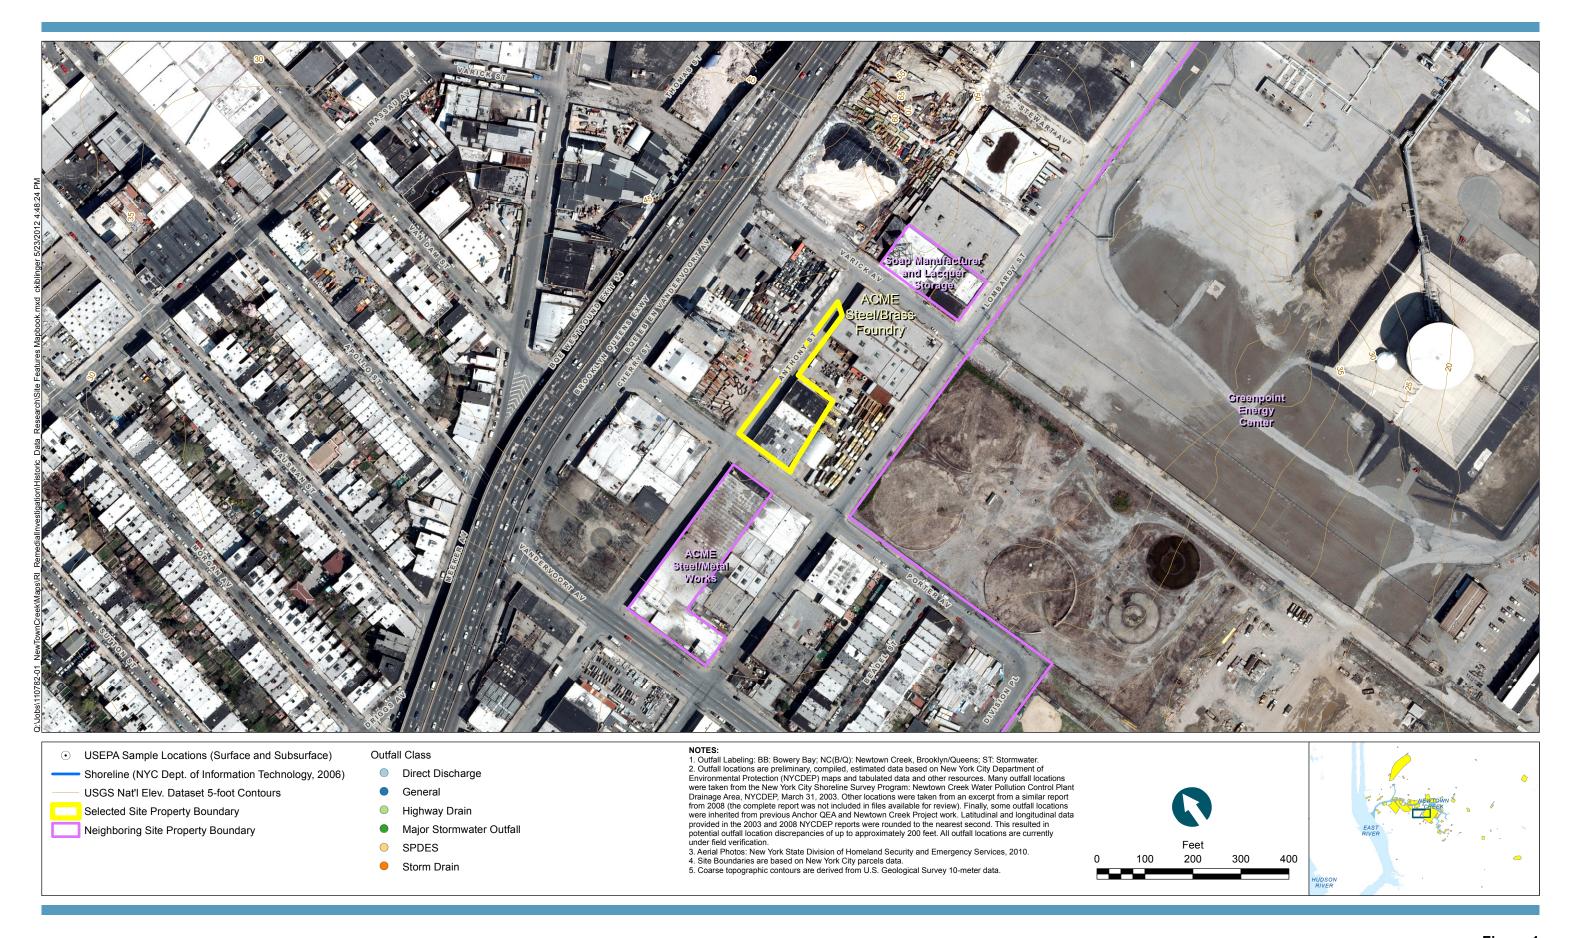
Figure 1 Site Vicinity Map: ACME Steel/Brass Foundry

The property occupies approximately 0.6 acre along Anthony Street and Porter Avenue in Brooklyn, New York. The property is located 0.5 miles to the west of Newtown Creek. The property is between 50 and 55 feet above mean sea level. A slight rise in the regional topography is located to the east of the property causing the ground to slope away from the site to the north, south, and west (see Figure 1). The property is occupied by a large building

The property and the area surrounding are zoned manufacturing with residential and park areas beyond. The adjacent lot to the south currently appears to be used by a trucking company, Citywide Demolition & Rubbish Removal (Google Maps 2011). The property is adjacent to several other large structures including several additional structures, which are also part of ACME Architectural, Inc. manufacturing in the surrounding blocks. These additional facilities associated with ACME Architectural, Inc. manufacturing include properties at 211 Lombardy Street, 513 Porter Avenue, and 60 and 95 Anthony Street (EDR 2010). The property is located close to three other environmentally regulated sites; ACME Steel/Metal Works (DAR Site #100) to the west, Soap Manufacturer and Lacquer Storage (DAR Site #104) to the east, and Greenpoint Energy Center (DAR Site #32) to the south (see Figure 1).

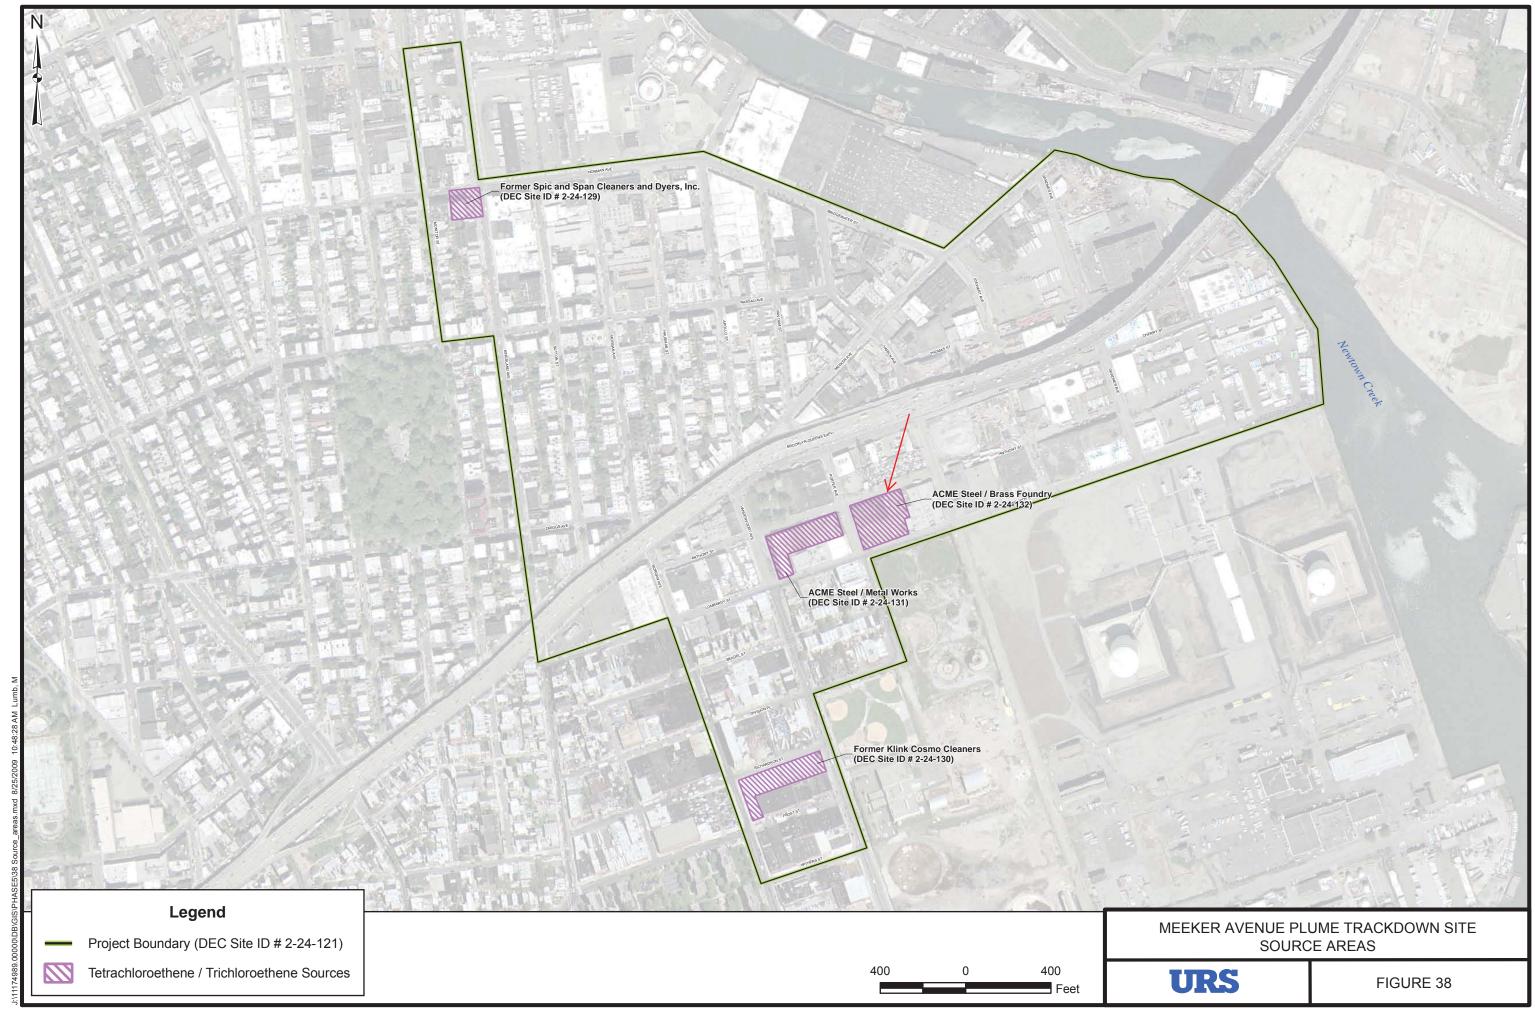
The site is located within Area 2 of the larger plume study area (see Attachment 2) where approximately ten shallow and three deep groundwater wells were installed throughout the course of the URS investigations in which soil sampling was conducted (URS 2007, 2008b). Soil borings were advanced using 4.25-inch inside diameter hollow stem augers (HSAs) and split spoon samples were collected continuously using standard penetration techniques (ASTM D1586-84) unless an obstruction was encountered. An additional 23 direct-push soil borings were installed. Soil samples were collected in one foot intervals and were field screened with a photoionization detector (PID). Up to two samples from each boring were kept for laboratory analysis, one from the interval just above the water table and one from

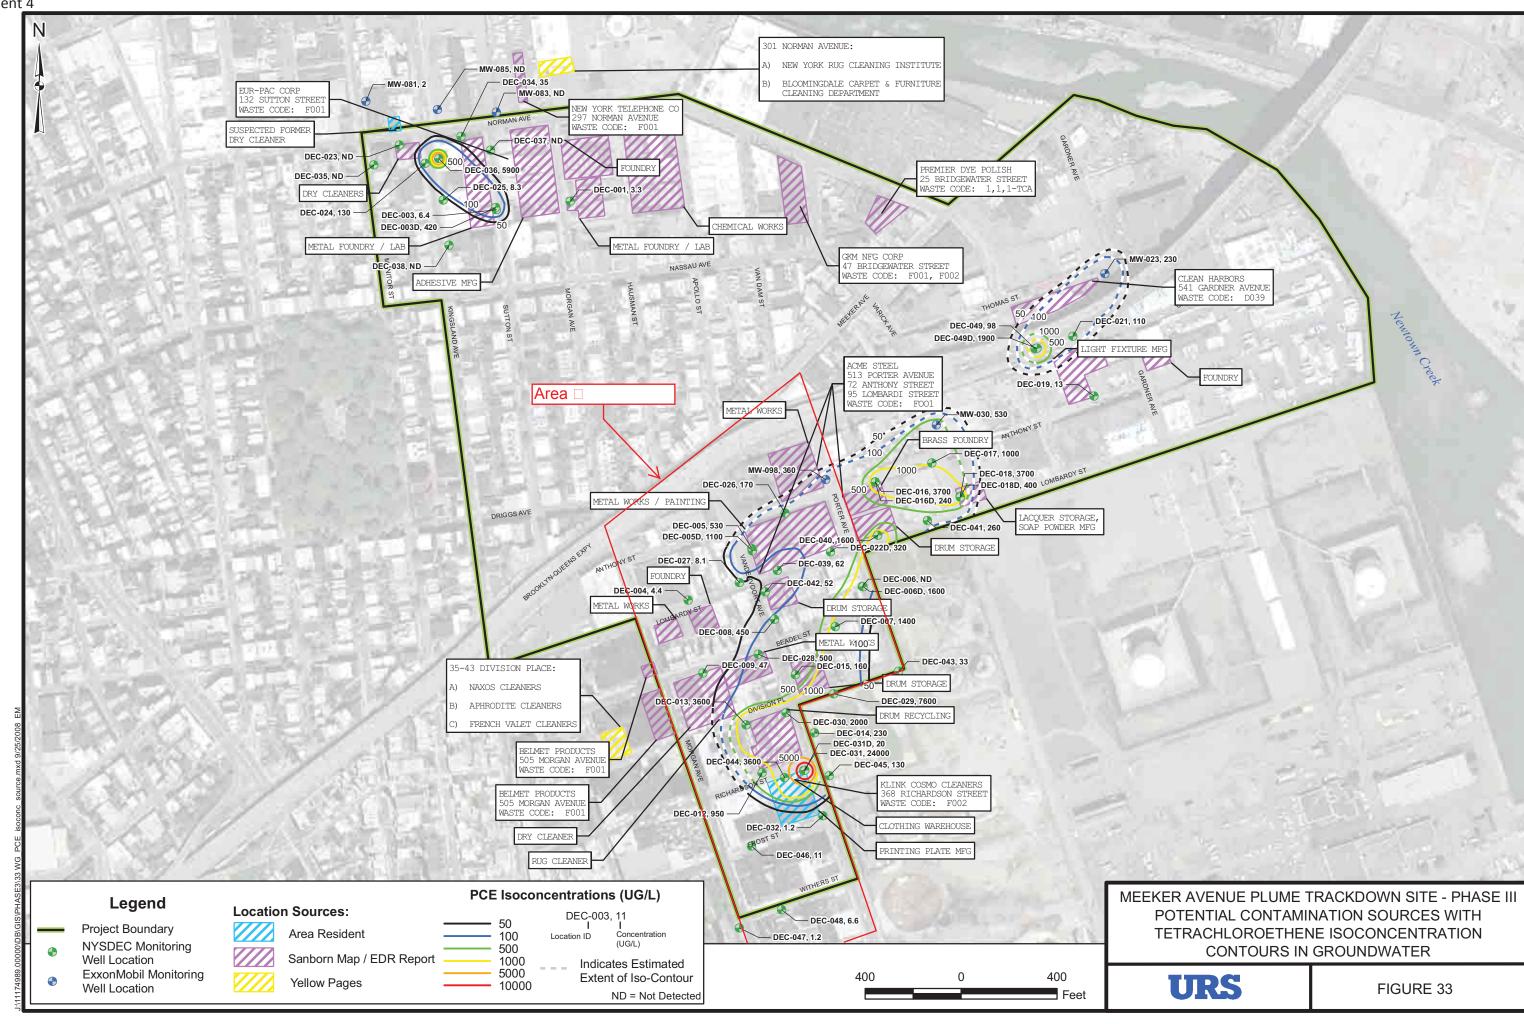
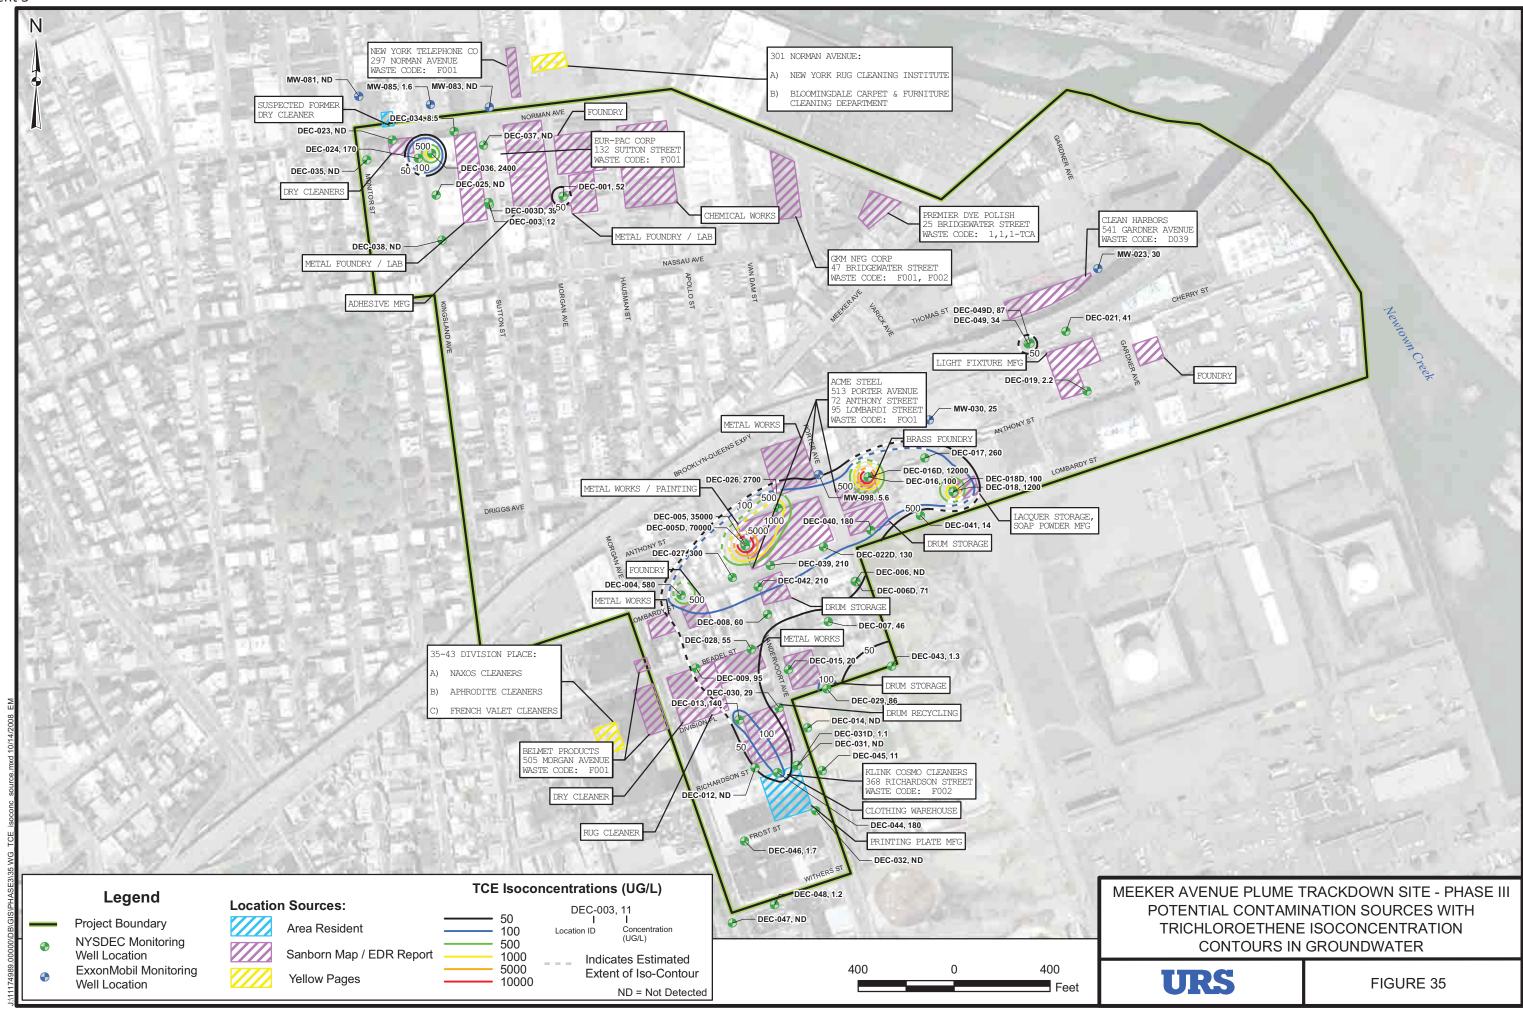
Large PCE and TCE plumes were identified under and beyond the site during the Meeker Avenue Plume Trackdown study (URS 2007, 2008b). PCE and TCE isometric contour maps are presented in Attachments 4 and 5. As shown in the attachments, the PCE and TCE contamination seen in Area 2 of the Meeker Avenue Plume Trackdown study can be characterized into two separate groundwater plumes. The first plume originates in the area
